Monitoring Survey at the Portland Disposal Site
August 2001

Disposal Area Monitoring System DAMOS

Contribution 140
January 2003

**MONITORING SURVEY AT THE
PORTLAND DISPOSAL SITE
AUGUST 2001**

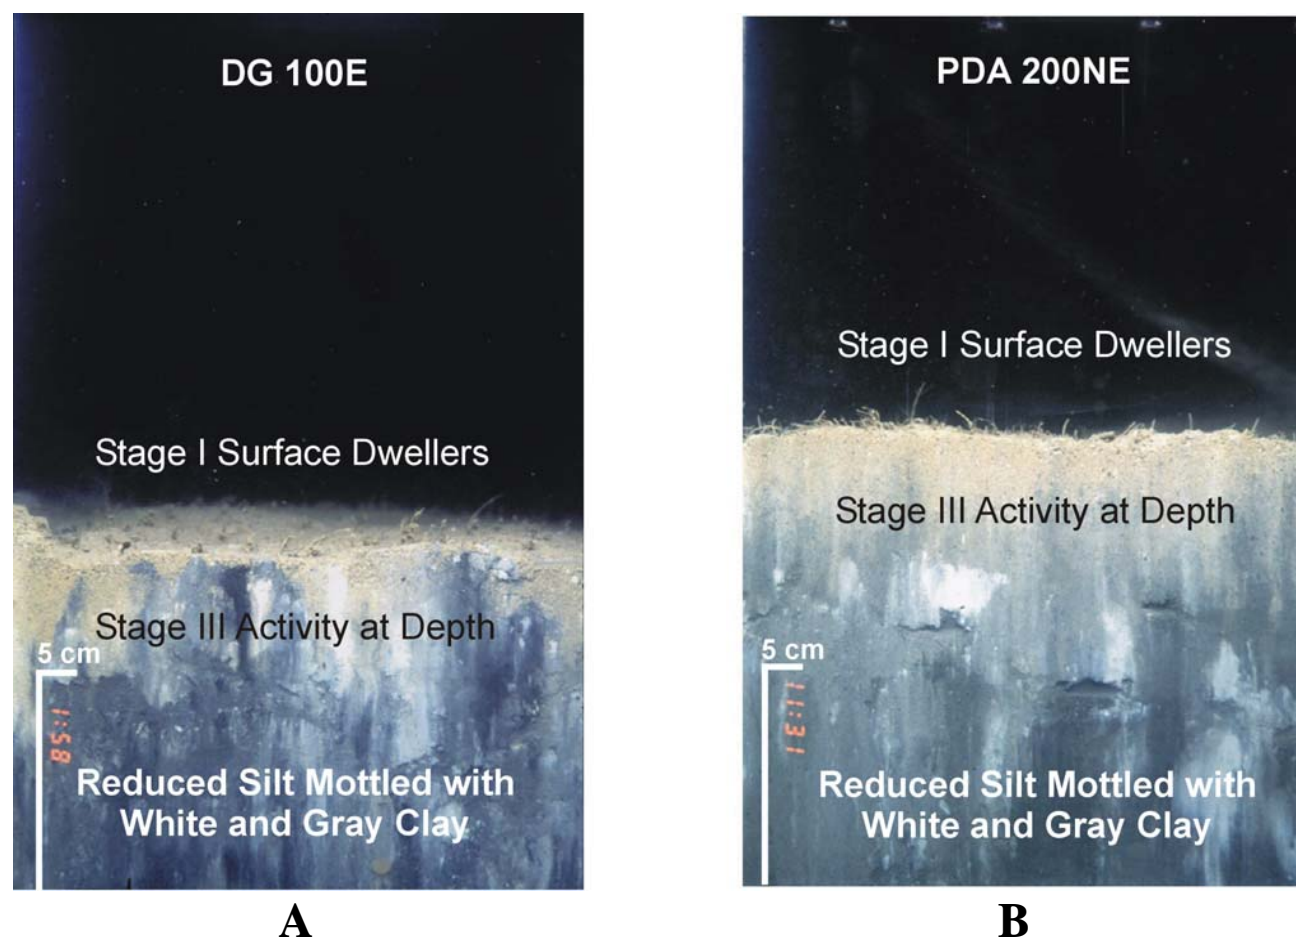
Figure 4-1. REMOTS® images collected from Station 100E over the DG Mound (A) and Station 200NE over the PDA 98 Mound (B) displaying strong similarities in sediment appearance, composition, and benthic recolonization

The majority of the material identified over the DG Mound was composed of gray silt and white cohesive clay chips, similar to the sediment observed at many PDA 98 Mound stations (Figure 4-1). The presence of this type of material within the DG Mound survey grid suggests the majority of the deposit originated from the 155,800 m³ of dredged material placed at the DG buoy during the third phase of dredging in Portland Harbor (outer channel) in the spring of 1999 (Figure 1-4). The 18,300 m³ removed from the Fore River in the winter of 2000 was also present in the surficial sediment layers. However, due to the age and volume of the sediment deposit, as well as the origin of the material, differentiation between the 1999 (155,800 m³), 2000 (18,300 m³), and 2001 (12,350 m³) deposits was not possible.
